Floor Joint Repairs

Joint "Edge" Repair

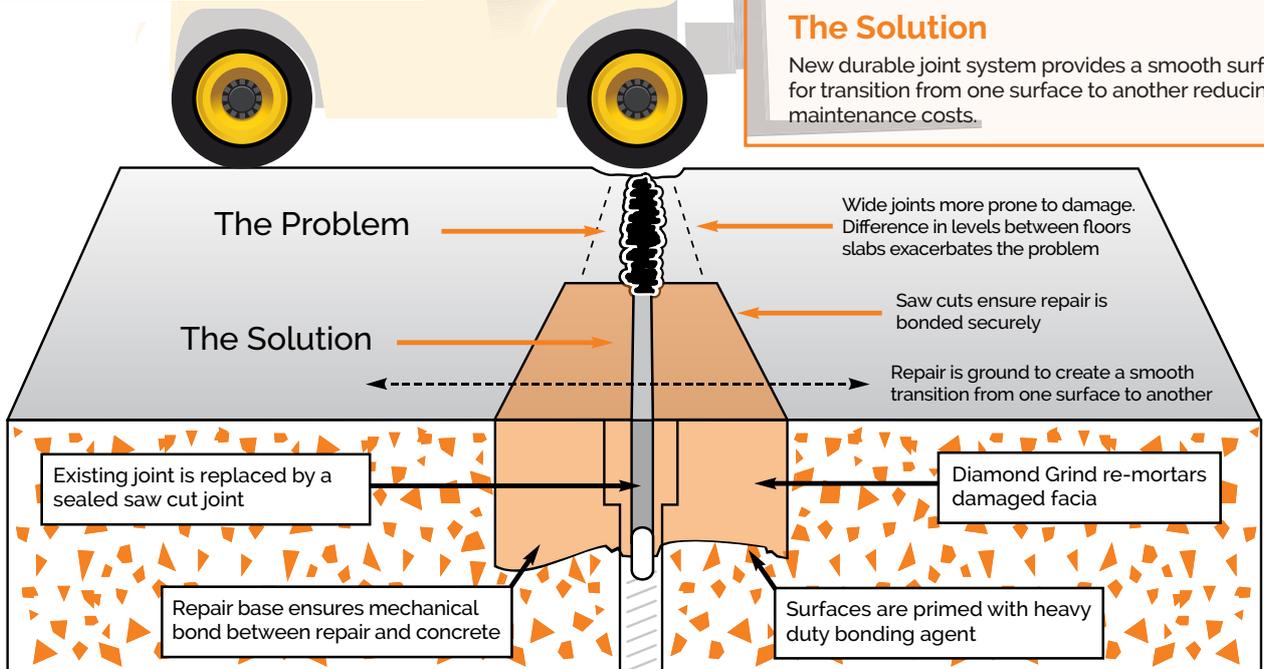
The Problem
Solid wheels and heavy loads transported by mobile plant cause major damage to the joint edge.

The Solution
New durable joint system provides a smooth surface for transition from one surface to another reducing maintenance costs.

Diamond Grind's method of repair (shown below) allows for a 50mm wide 'traditional expansion joint' to be replaced with a neat 5mm wide, fully sealed saw cut. Each repair is ground flush with the adjacent floor surface to ensure that wheeled traffic has a smooth transition over the repaired joint.
